Technical Bulletin

ATS-137-4
2013-01-15

NEW IMPROVEMENTS IN THE APPEARANCE OF INSTALLED Pilkington **Energy Advantage**[™] Low-E Glass

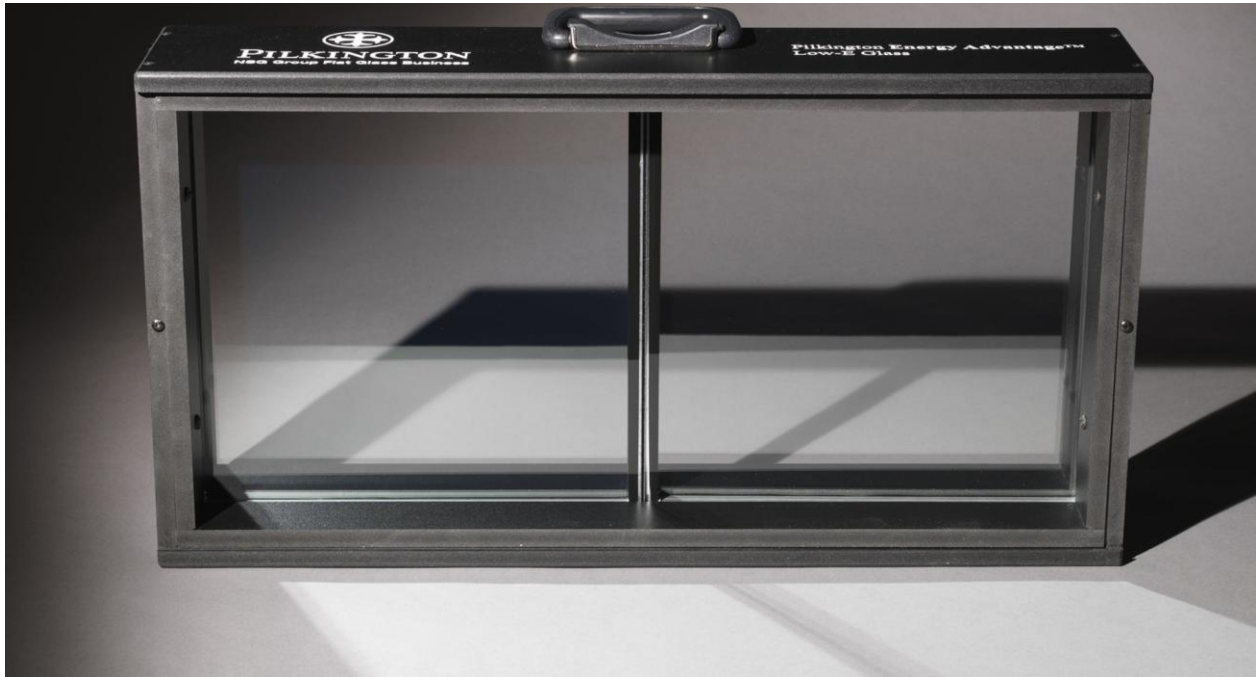
Pilkington **Energy Advantage**[™] is made of an extremely fine polycrystalline hard material that cannot be seen under most lighting and viewing conditions. It is possible to discern the presence of the coating under certain lighting conditions, such as when bright sunlight shines directly onto partly shaded, coated glass and there is deep shade on both sides of the glass.

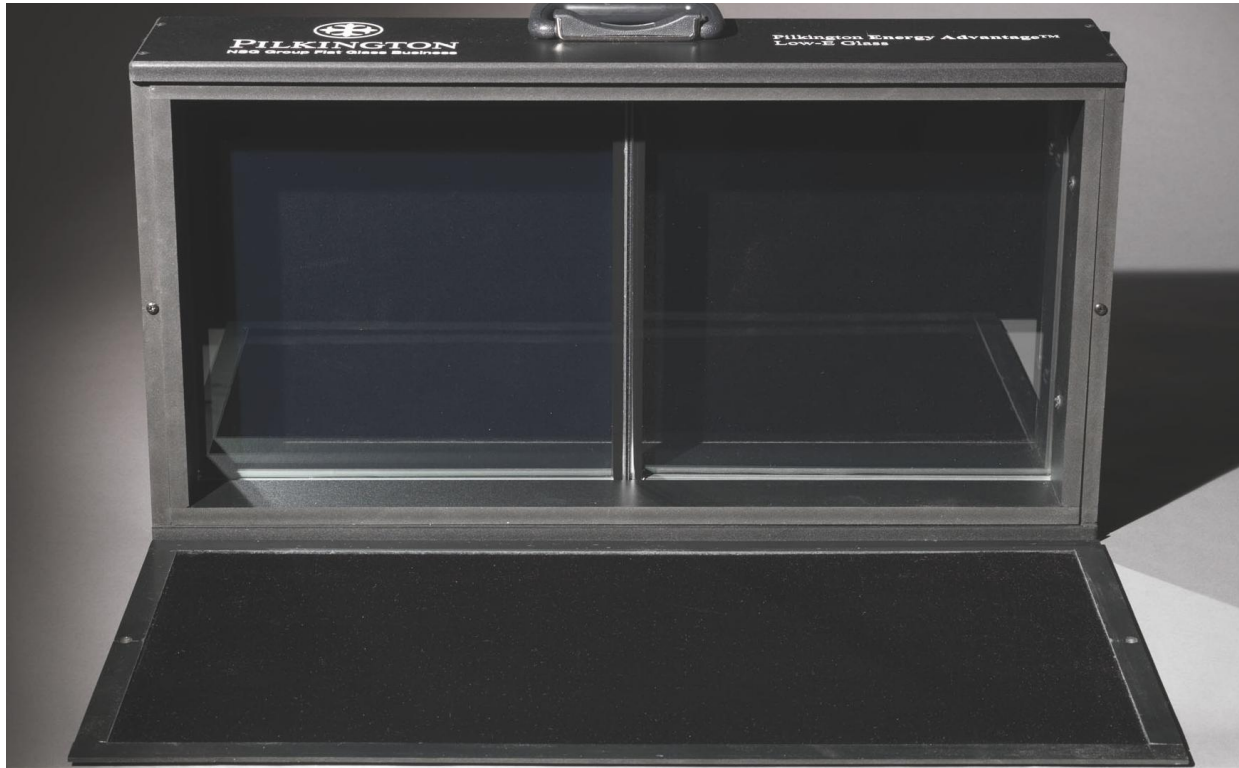
Using extreme lighting conditions for the reflected images of a typical window, the residual haze of the older (2010 and earlier) product can be seen in the left hand IG unit of the following photo. A studio spotlight simulates direct sunlight (with the same set-up as in the photo above), and eliminating (with black velvet) the distracting transmitted and reflected images of a typical window, the residual haze of the older (2010 and earlier) product can be seen in the left hand IG unit of the following photo. The IG unit on the right hand side of the original photo below barely shows the miniscule amount of haze that can be found in 2011 production of 2.5, 3.0 and 4.0 mm thick Pilkington **Energy Advantage™**.

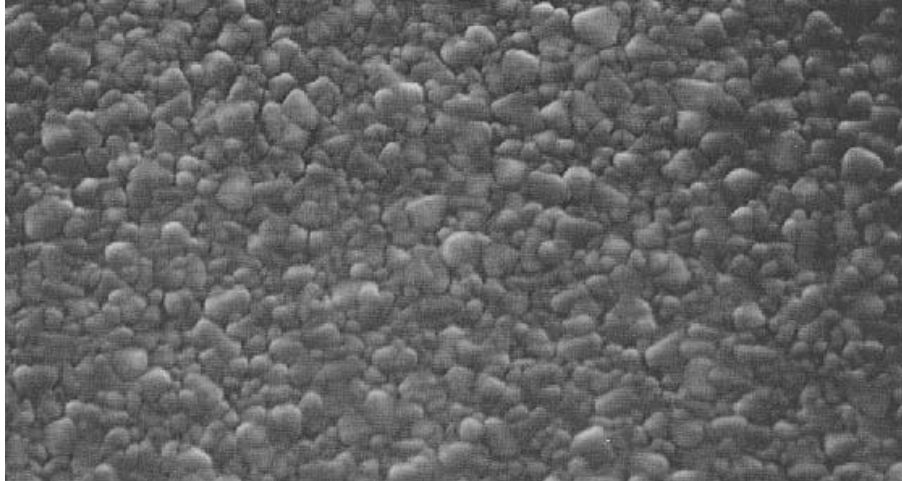
Fig.1. Typical grain structure, magnified 20,000 times.

Pilkington **Energy Advantage™** pyrolytic coatings are made by the chemical vapor deposition (CVD) process, creating a hard polycrystalline layer of tin oxide over color suppression underlayers. In an electron microscope picture, the polycrystalline structure of the surface of the tin oxide top coat can be seen as a layer of closely packed grains. Daylight can easily pass, with less than 1% scattering, through this coating because each grain is actually smaller than the wavelength of visible light.

The illustration below shows the surface of the coating magnified 20,000 times.

The extremely small size of the grains makes them invisible in most lighting conditions.

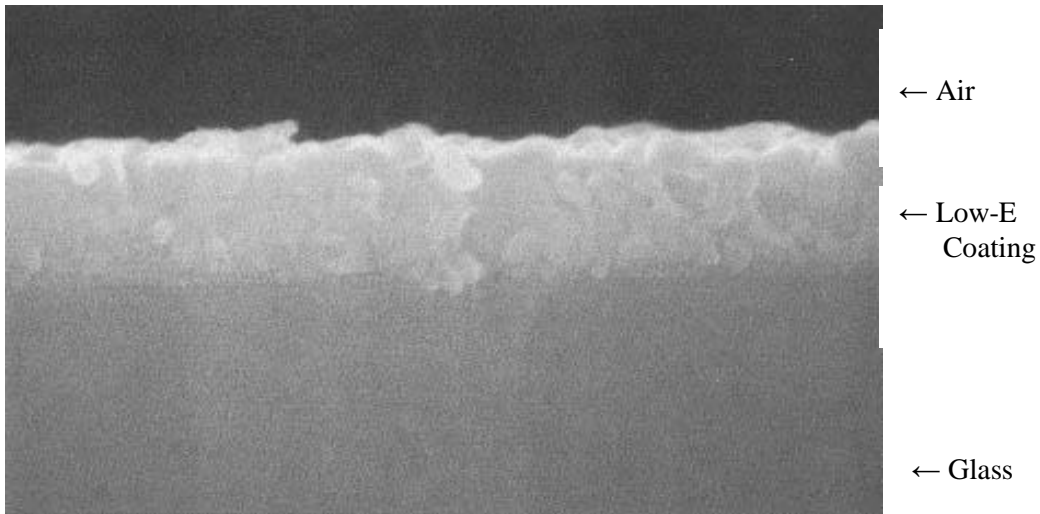
Fig.2. Cross-section showing coating uniformity, magnified 50,000 times.

The following electron microscope image shows a cross-section through the Pilkington **Energy Advantage**™ coating. The polycrystalline nature of the coating contrasts with the non-crystalline 'super-cooled liquid' nature of the solid glass underneath the coating.

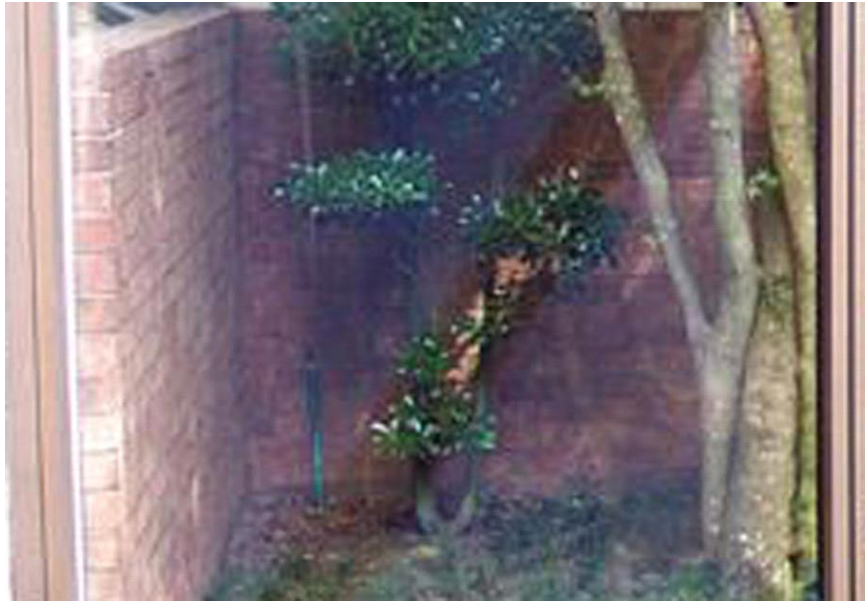
It is possible to discern the presence of the coating under certain lighting conditions, such as when bright sunlight shines directly onto partly shaded, Low-E coated glass and there is deep shade on both sides of the glass. When looking out through the glass towards a deeply shaded background, the short wavelength component (blue) of the sunlight appears slightly scattered. This gives the coating a uniform, very faint blue appearance visible in the sunlit area. Longer wavelength red light is less scattered. In the 2003 photo below the haze was made more noticeable by the complete lack of any visible haze in any contrasting glass shaded areas, such as in the diagonal shadow on the glass.

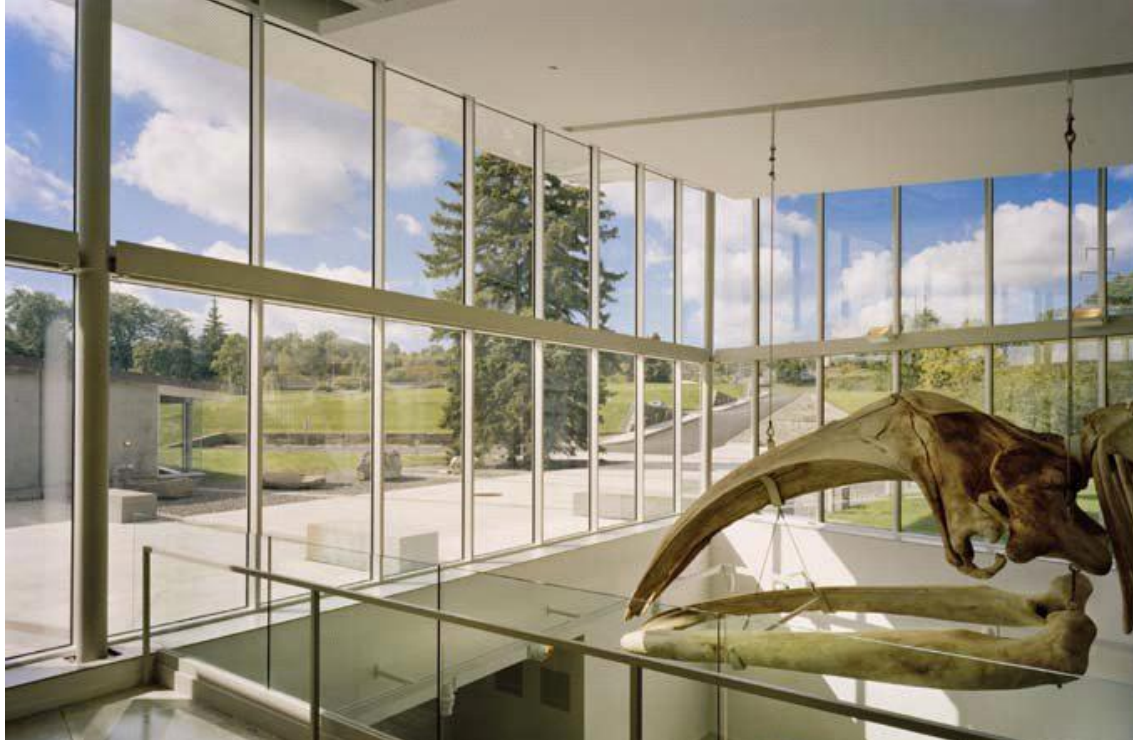
The following photo is an example with no visible haze, even in the sunlit Pilkington **Energy Advantage**[™] Low-E Glass (pre 2011 production), because there is no deep shade beyond the glass.

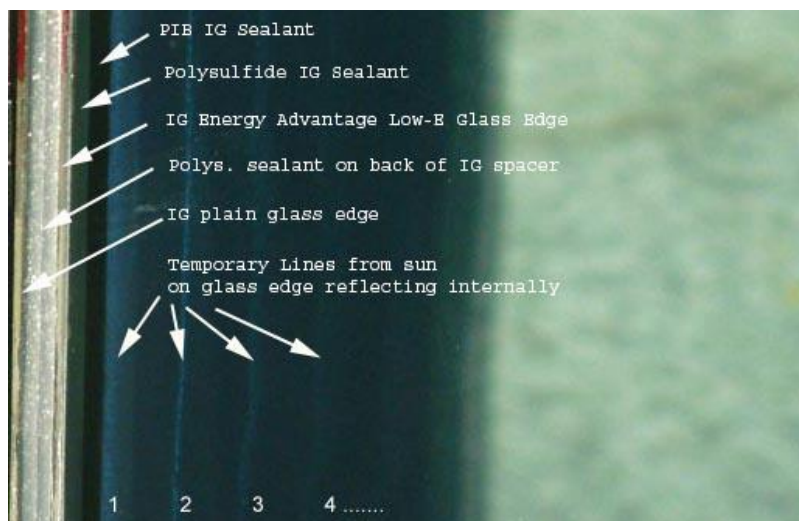
Fig.3. Temporary or Transient Lines caused by sunlight on an exposed glass edge

Before a light of low-e coated glass is glazed into a frame, sunlight, or a bright light, shining directly onto the glass cut edge can internally reflect within the body of the glass and produce a series of faint parallel lines a few inches from the glass edge where some reflected light is scattered by the coating. The photo below shows these lines. They are more visible on the left hand side of the glass where there is a dark background behind the glass. This effect completely disappears when the glass edges are shaded by being glazed into a normal sash or frame.

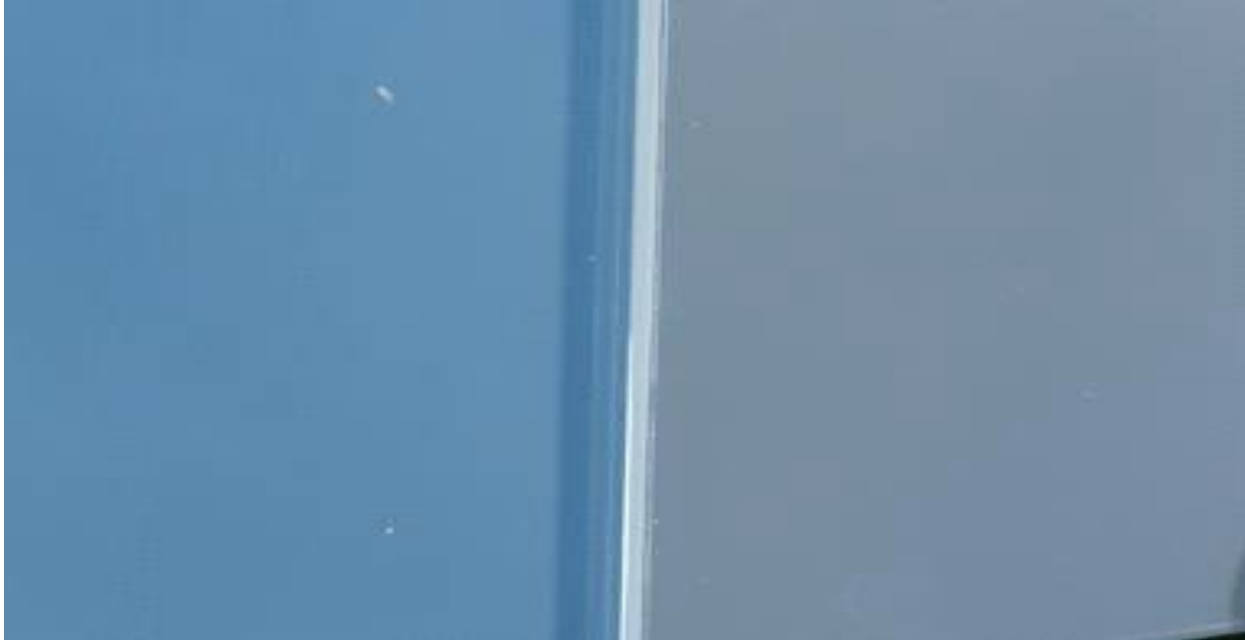
An alternate way to achieve the very high thermal insulation provided by the pyrolytic 'hard' Low-E coating in a double glazed unit, is to use a 'soft' sputtered coating produced off-line in a vacuum chamber. Such coatings must be protected from humidity by being sealed into an IG unit. The sputtered coating is typically removed or ground off at the perimeter to allow effective insulating glass sealant adhesion. Sputter coatings usually have some reflected color as seen in the left hand glass (1).

Sputter coat IG reflected color of a grey sky. The same sky reflected in adjacent clear glass IG

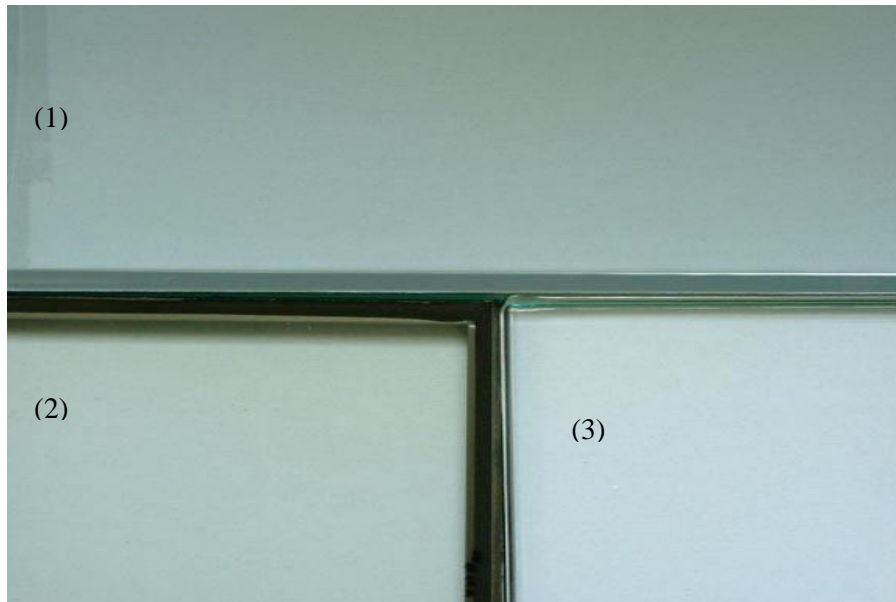
Viewed in transmission, in the photo below, the top IG unit (1) is sputter coated low-e, the lower left unit (2) is Pilkington **Energy Advantage™**, and the lower right IG unit (3) is clear glass with no low-e.

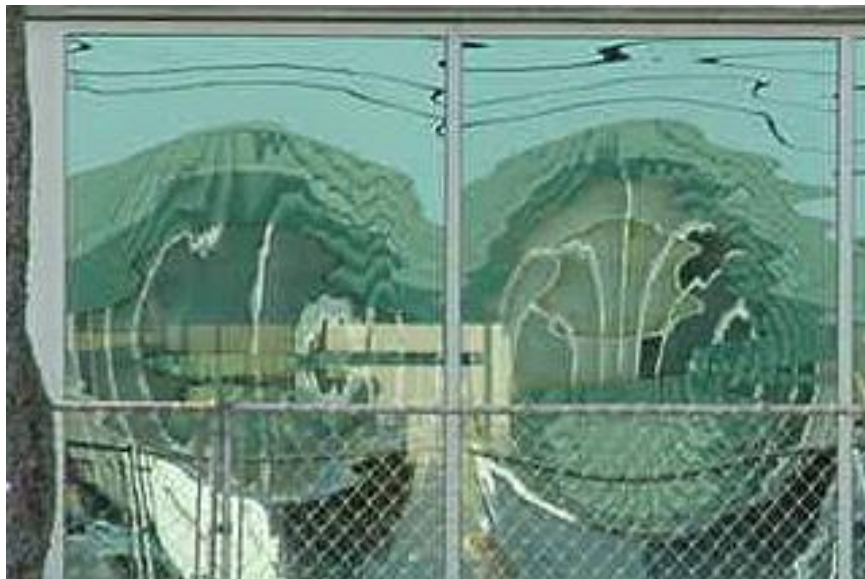
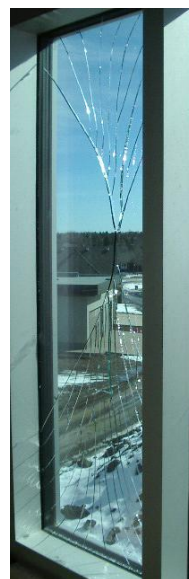
The use of three lites of plain glass in a triple glazed unit can also give insulation values similar to a double glazed unit with a low-e coating. But this involves a thicker and heavier window unit, with increased reflectivity, and more distortion in the reflected images when weather changes cause greater expansion and contraction of the wider total air space. There is an increased risk of breakage with improperly balanced air spaces, compared to sealed double glazing.
